Belle II実験データ収集システム

山田悟 (KEK素核研)

Belle II データ収集システム (今回は読み出しシステムの話を中心に)

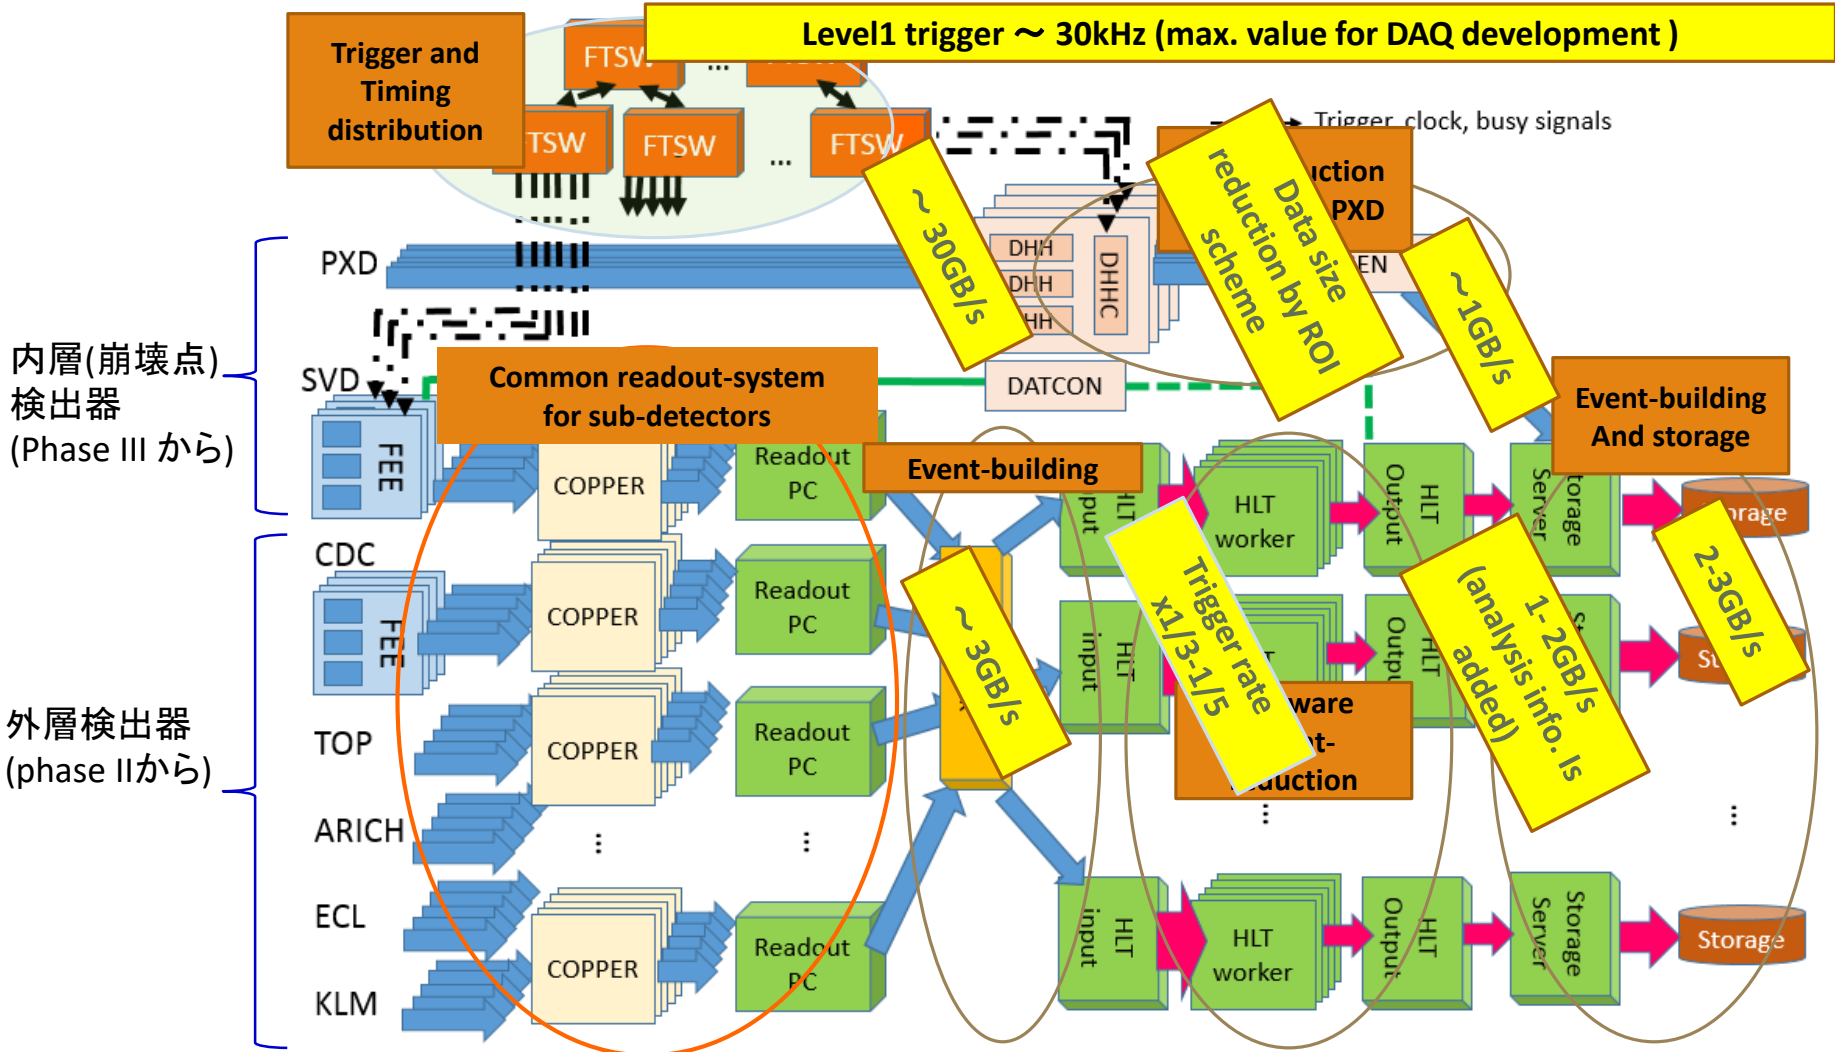
- FEEとのinterfaceは各検出器共通(PXD以外)
- HLTによるrate reduction + Region of InterestによるPXDのevent size reduction

内層(崩壊点) 検出器 (Phase III から)

外層検出器 (phase IIから)

X210 readout boards X40 Readout PCs 1GbE/10GbE switch x10 High Level Trigger+storage unit

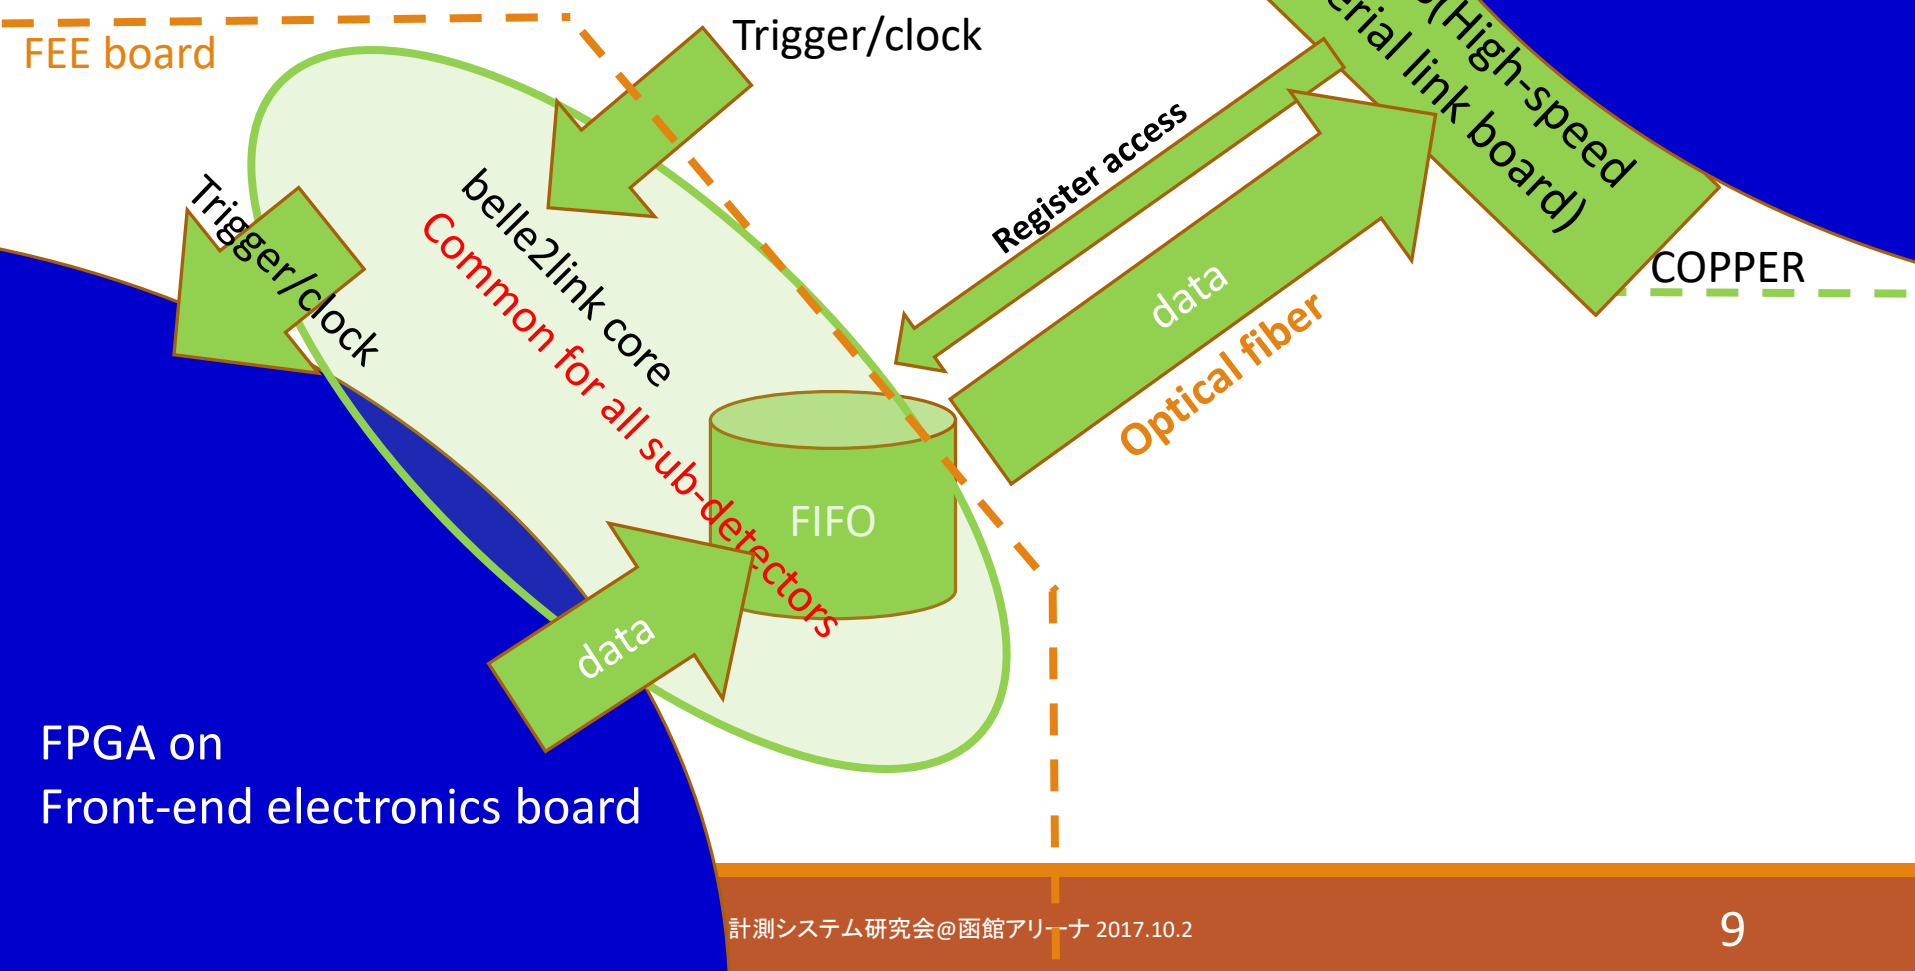
フロントエンド検出器とバックエンドDAQとの接続

- 2つのインターフェイスが必要
 - FEE とトリガータイミング分配システム:
 - FEE とバックエンドDAQ (データフロー)
 - データフローについては各検出器に共通の通信用firmware (Rocket I/Oベース)を使用
→ belle2link

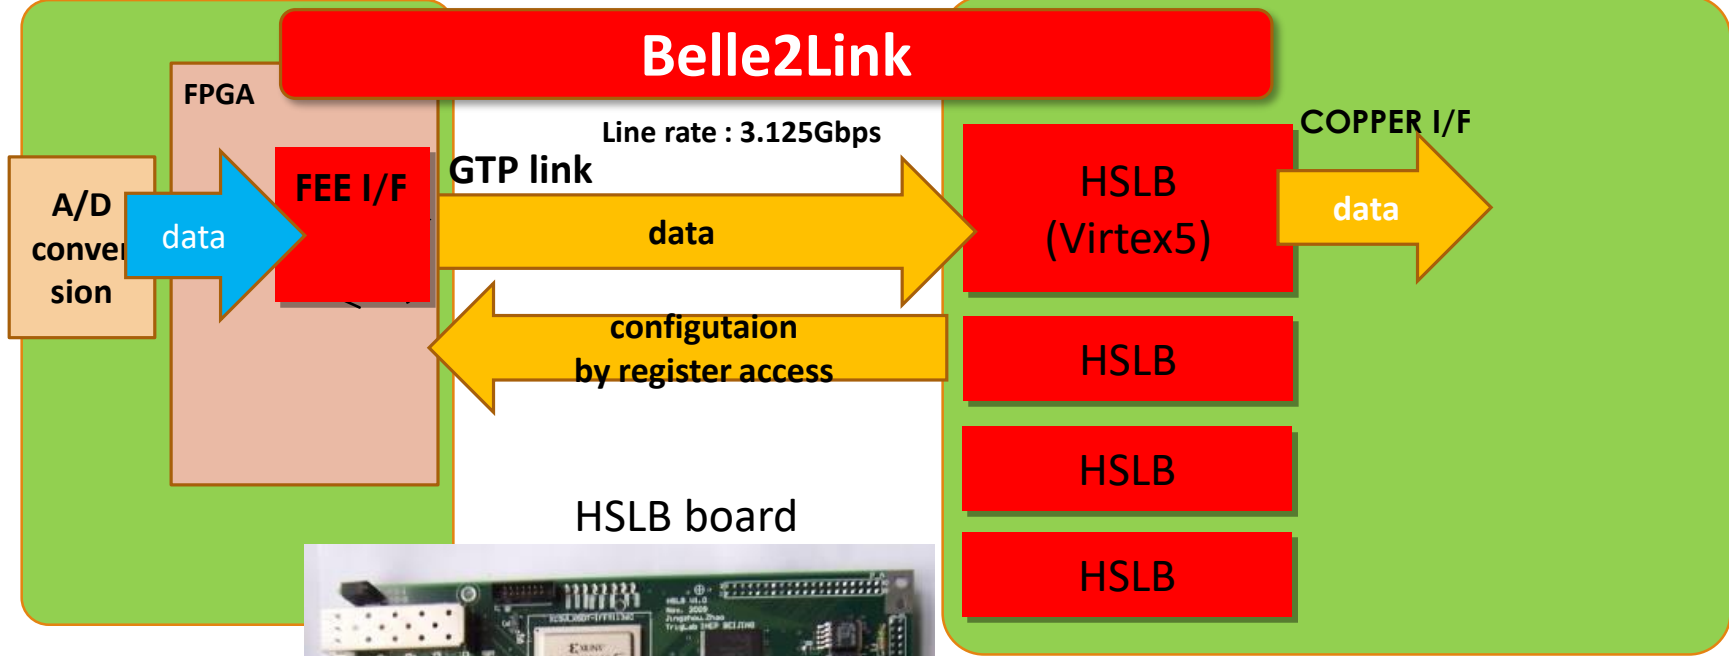
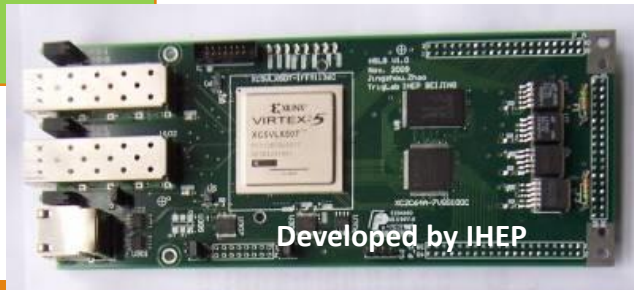
フロントエンド電子回路からのデータ読み出し

Belle2Link : (D. Sun et. all, hysics Procedia Volume 37, 2012, pp. 1933-1939)

Unified high speed link which connects Front-End Electronics (FEE) and DAQ system for signal with data transmission based on Rocket I/O

FEE side : Functions for I/F with FEE and Trigger Timing Distribution on FPGA

DAQ side : **High Speed Link Board(HSLB)** as a data receiver

Front-end electronics

COPPER : data readout board

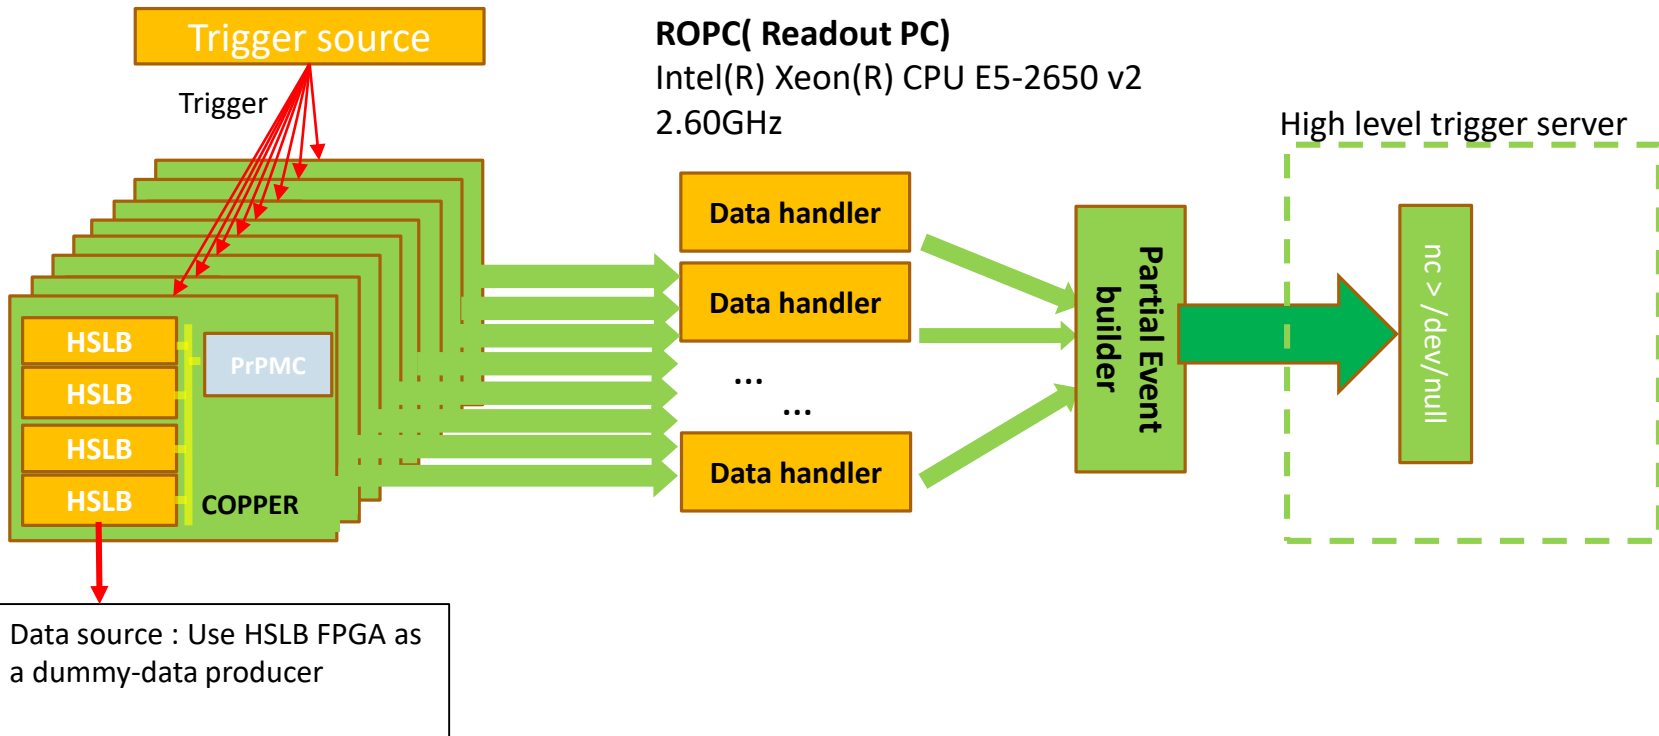
パフォーマンス測定(2) : COPPER -> readout PC

- 1ROPC and several COPPERs.
- # of COPPERs differs over sub-detectors due to the difference of event size
- Provide trigger to COPPER board to produce dummy data by HSLB.

We can test

- Processing power of COPPER and ROPC
- data-transfer performance between COPPER and ROPC, ROPC and HLTin.

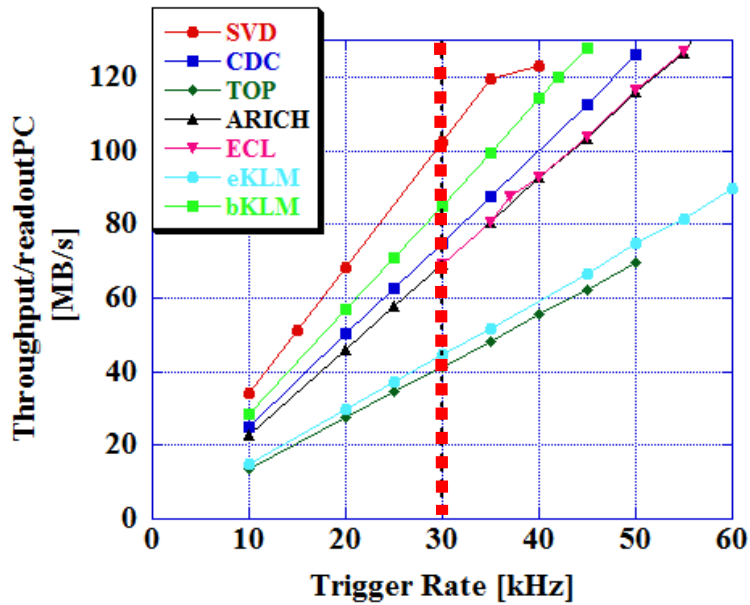
Throughput on ROPC

- 35kHz for SVD is the max. event rate.
- Bottleneck : Output data flow to HLT is near the limit of GbE.
 - CPU usage on COPPER CPU is still room to increase the rate
- Increase # of Readout PCs or increase througthoput between ROPC and HLT will increase the limit.

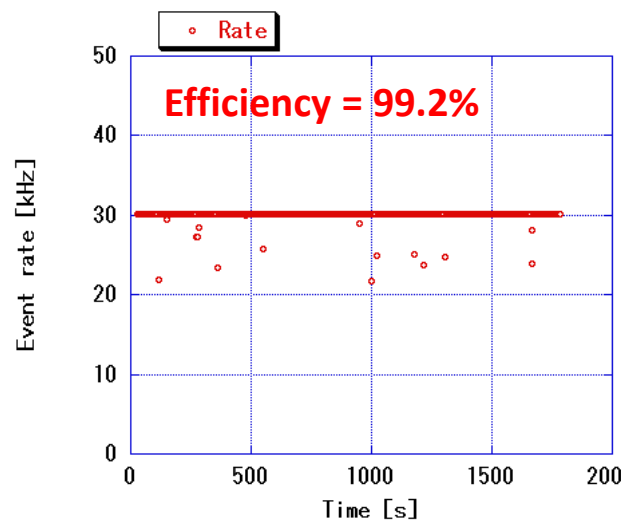
Constant 30kHz trigger rate

- Setup : 36FEE -> 18 COPPERs -> 7 readout PC
- Throughput : about 33MB/s/COPPER (the expected event size from MC)
 - Event size was adjusted by HIT threshold of ECL FEE
 - Total throughput for Barrel ECL : 600 MB/s
- Constant 30kHz trigger -> efficiency = 99.2%
- Pseudo-Poisson 30kHz trigger -> efficiency = 98.2 %
 - The deadtime comes from trigger limitation (5trigger in 26us due to SVD FEE).

-> High efficiency(nearly 100%) was achieved !

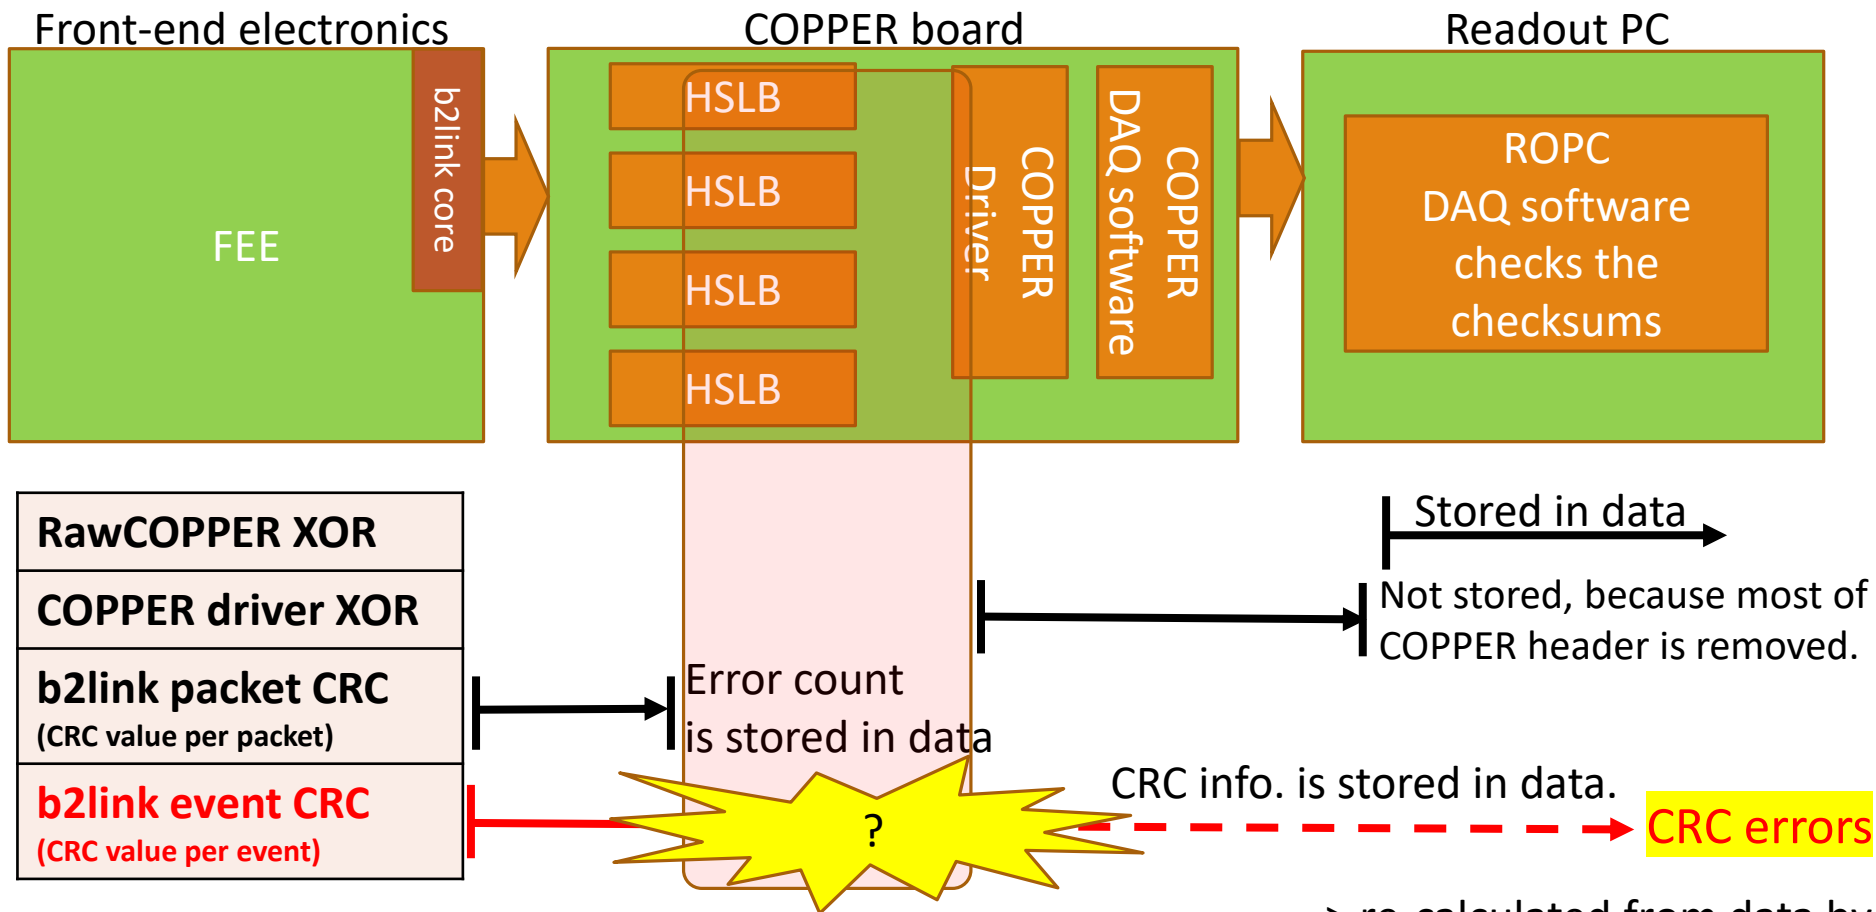
How CRC error is detected

“b2link packet CRC” has not been observed.
-> b2link transmission is O.K.
But “b2link event CRC” error was detected.
-> Data should be corrupted after receiving data from a FEE.

-> re-calculated from data by readout PC

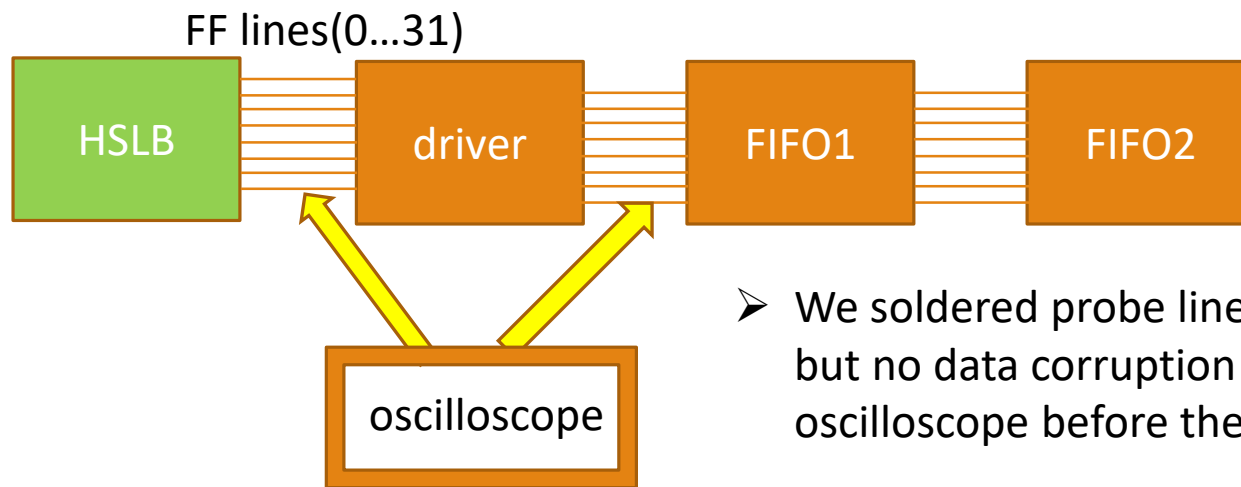
C. オシロで “feffffff 00000000” を探す

- We soldered probe lines on a COPPER board but no data corruption was detected by an oscilloscope before the 1st FIFO.

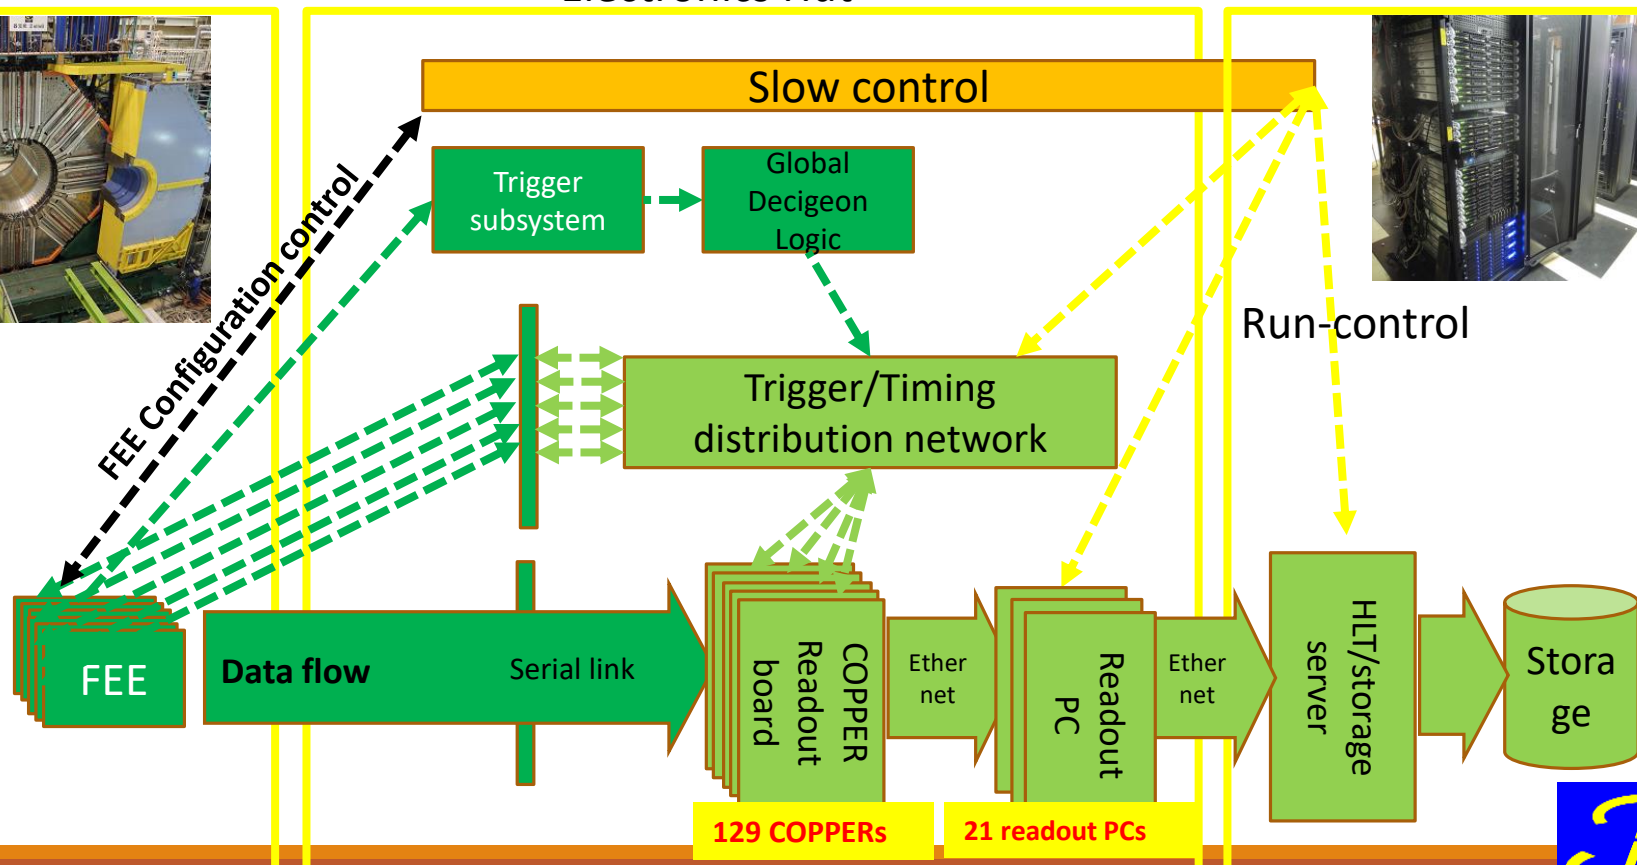
宇宙線試験でのデータ収集システム

- 実際のビームランで使うDAQシステムを使用
- Front-End Electronics boards はそれぞれの測定器で異なる
- FEE -> COPPER読み出しボードのprotocolは統一されており、backend DAQは各測定器共通。

Electronics Hut

Server room

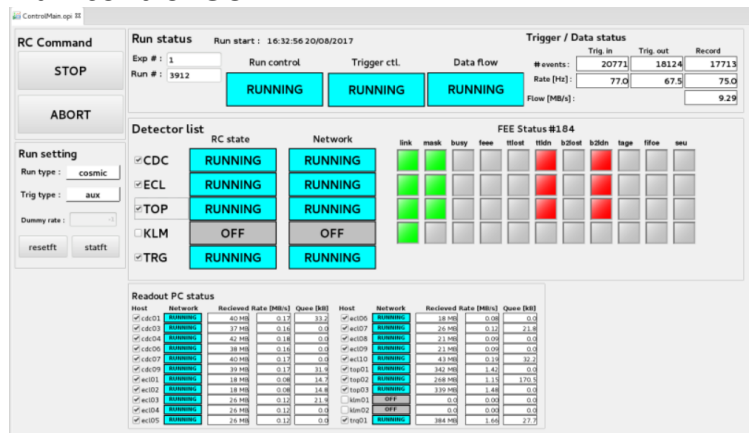
Run-control GUI

- 実際のbeam runと同様に、non-expertのexperiment shifterがデータ収集を担当し、夜間もデータ取得
 - Chat tool (rocket chat)でexpert-shifterのcommunication
- High Level TriggerにてオンラインでCDCのtracking
- 各検出器のdata qualityのonline monitor

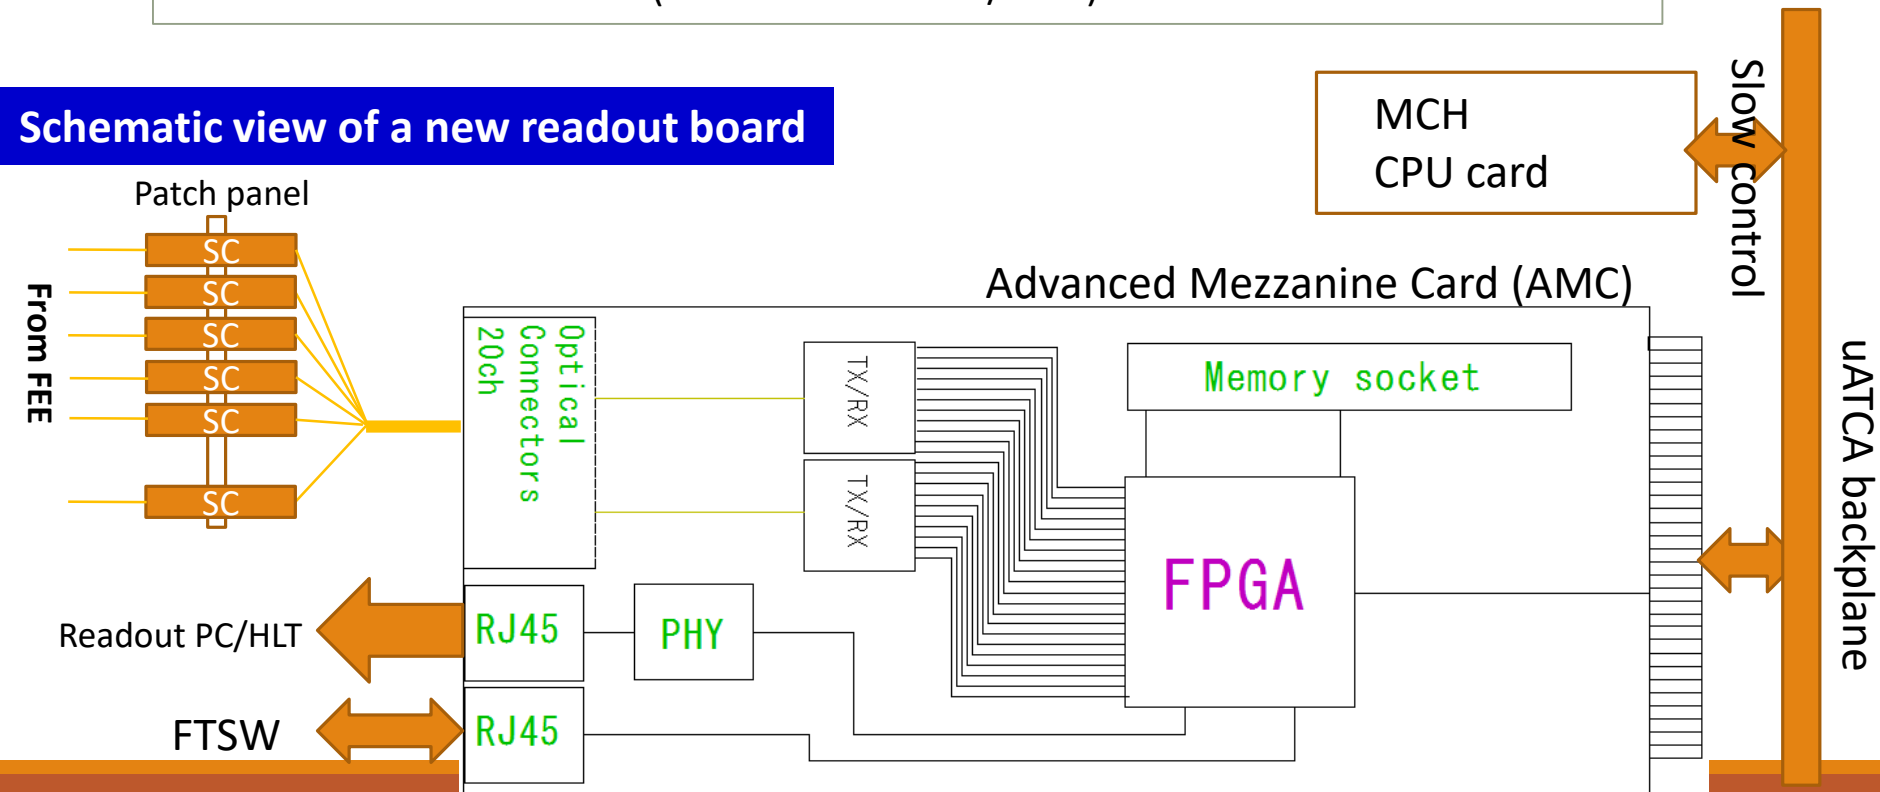
Schematic view of a new readout board

New readout system = High-density FPGA-based system using uTCA

- Data processing speed
 - Fast FPGA-based data processing
- Data transfer speed
 - 10GbE (directory connected to a HLT unit) or 1GbE (keep readout PCs)
- Compact and high-density system
 - high density connector and higher throughput
- Easier maintenance
 - Currently : 5 COPPERs, 5 TTRXs, 5PrPMCs, 20HSLBs
 - > one AMC board (in the case of 20ch/AMC)
